Landusky Mine Reclamation Progress

- **Reclamation Includes:**
 - Backfilling
 - Regrading/Lime Amendment
 - Barrier Placement
 - Soil Placement
 - Revegetation
 - Maintenance
- **Some Reclamation done by ZMI prior to 1998**
- **Interim Reclamation began in 1999 by DEQ and BLM after site abandonment by ZMI**
- **Over \$ 7 Million in additional reclamation funds provided by BLM and DEQ**

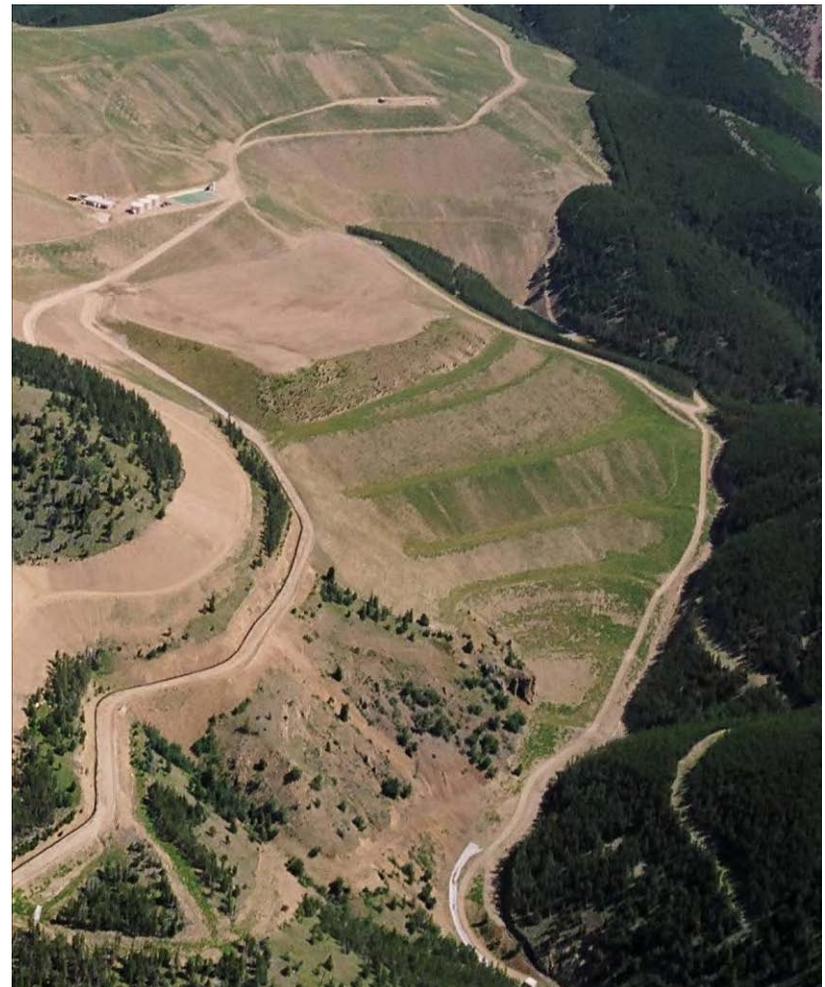
1993. Mill Gulch waste rock dump in operation. Contains 17 million tons. Topsoil stockpile on dump top. Active L87 and L91 leach pads in background.

July 2005. Regraded, benched, and capped Mill Gulch rock dump. L87 and L91 leach pads with second year vegetation growth in background.

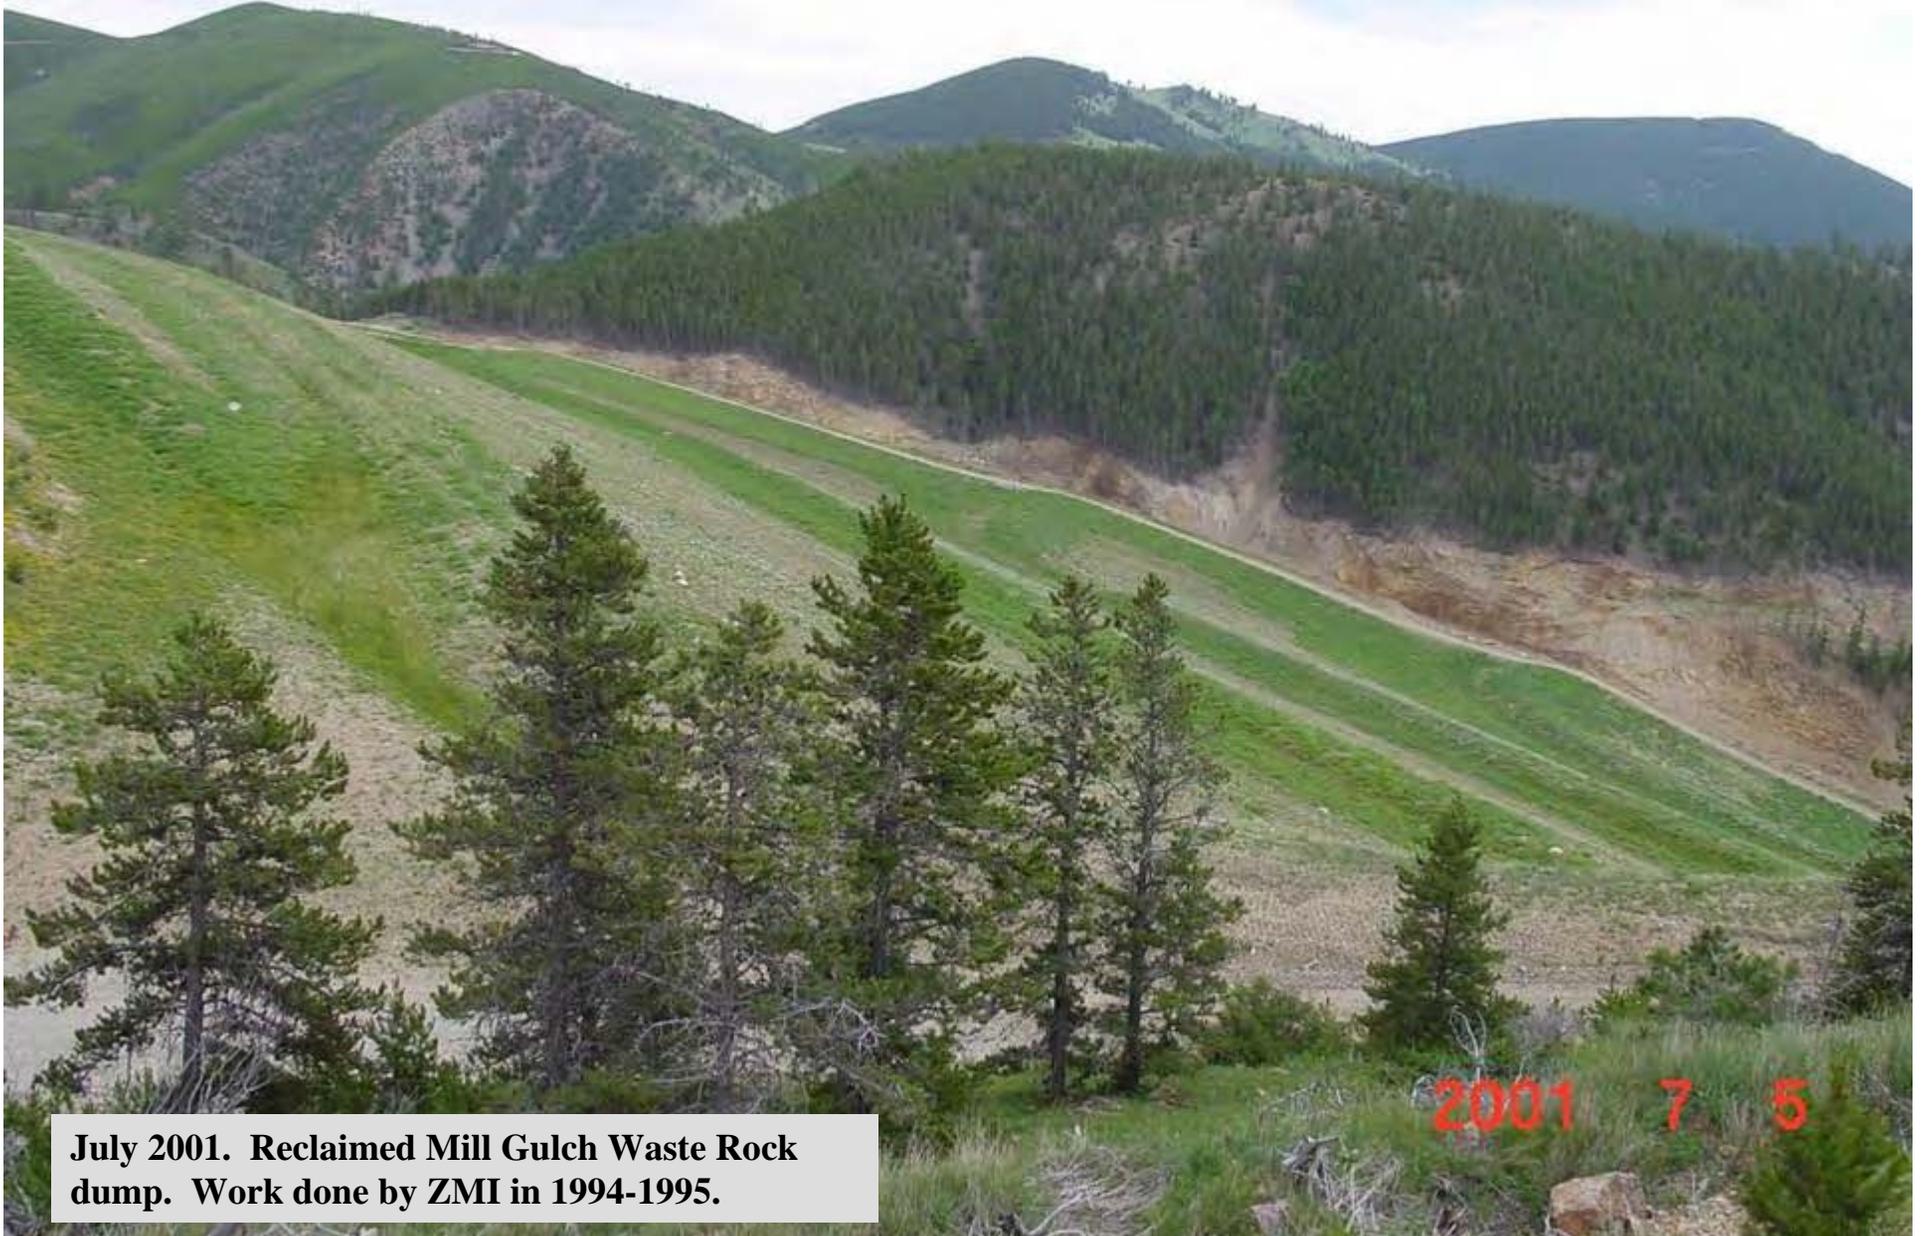
**Mill Gulch Waste Rock Dump
Revegetated in 1995**

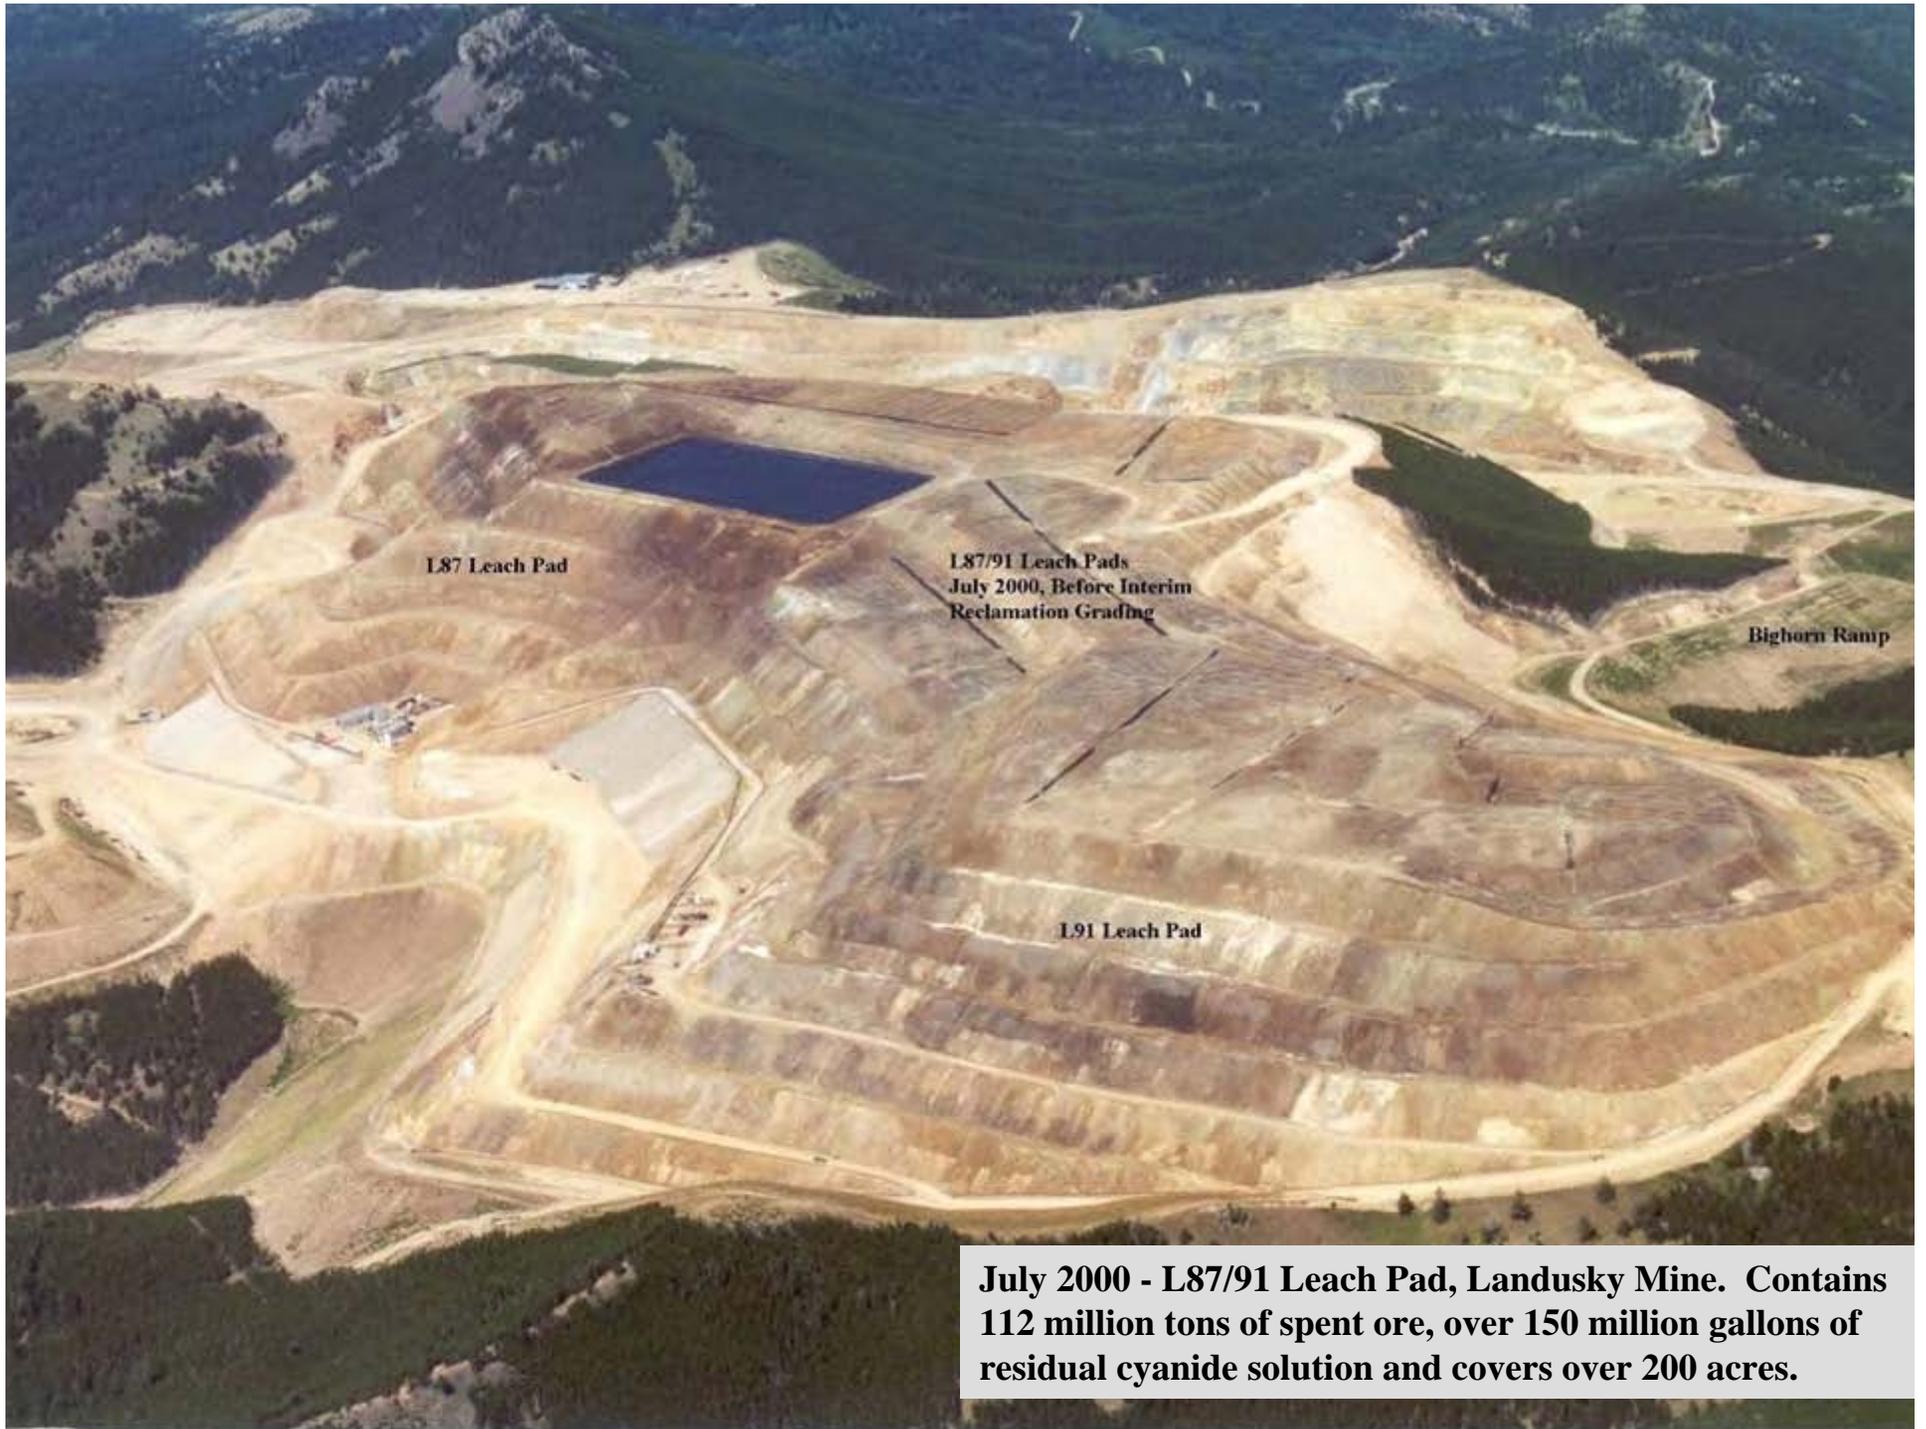
July 2000 - L87/91 Leach Pad, Landusky Mine. Contains 112 million tons of spent ore, over 150 million gallons of residual cyanide solution and covers over 200 acres.

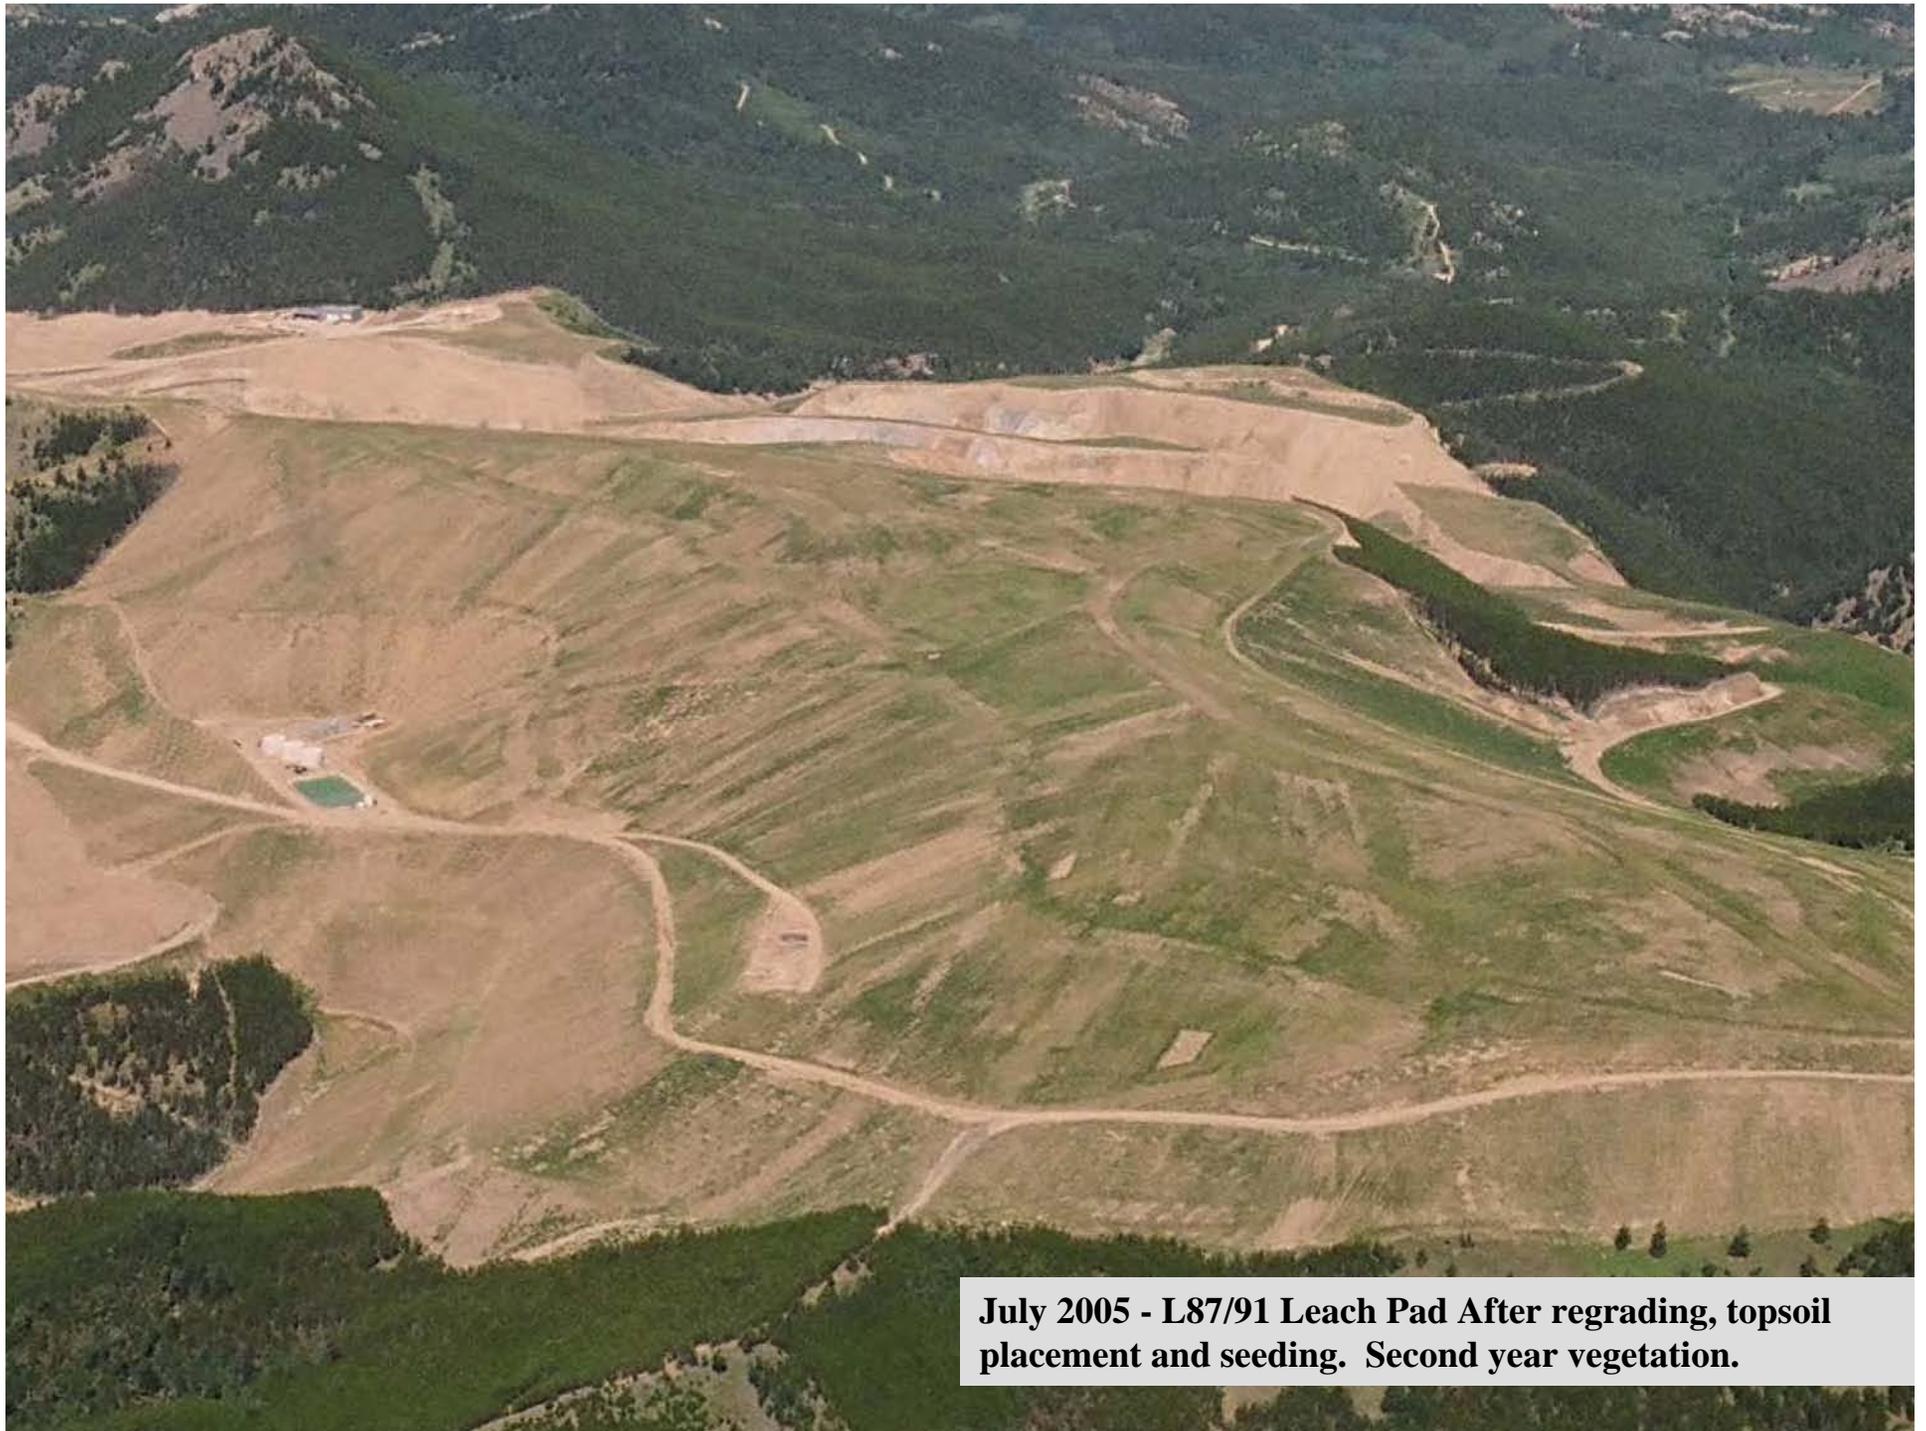
July 2005 - L87/91 Leach Pad After regrading, topsoil placement and seeding. Second year vegetation.

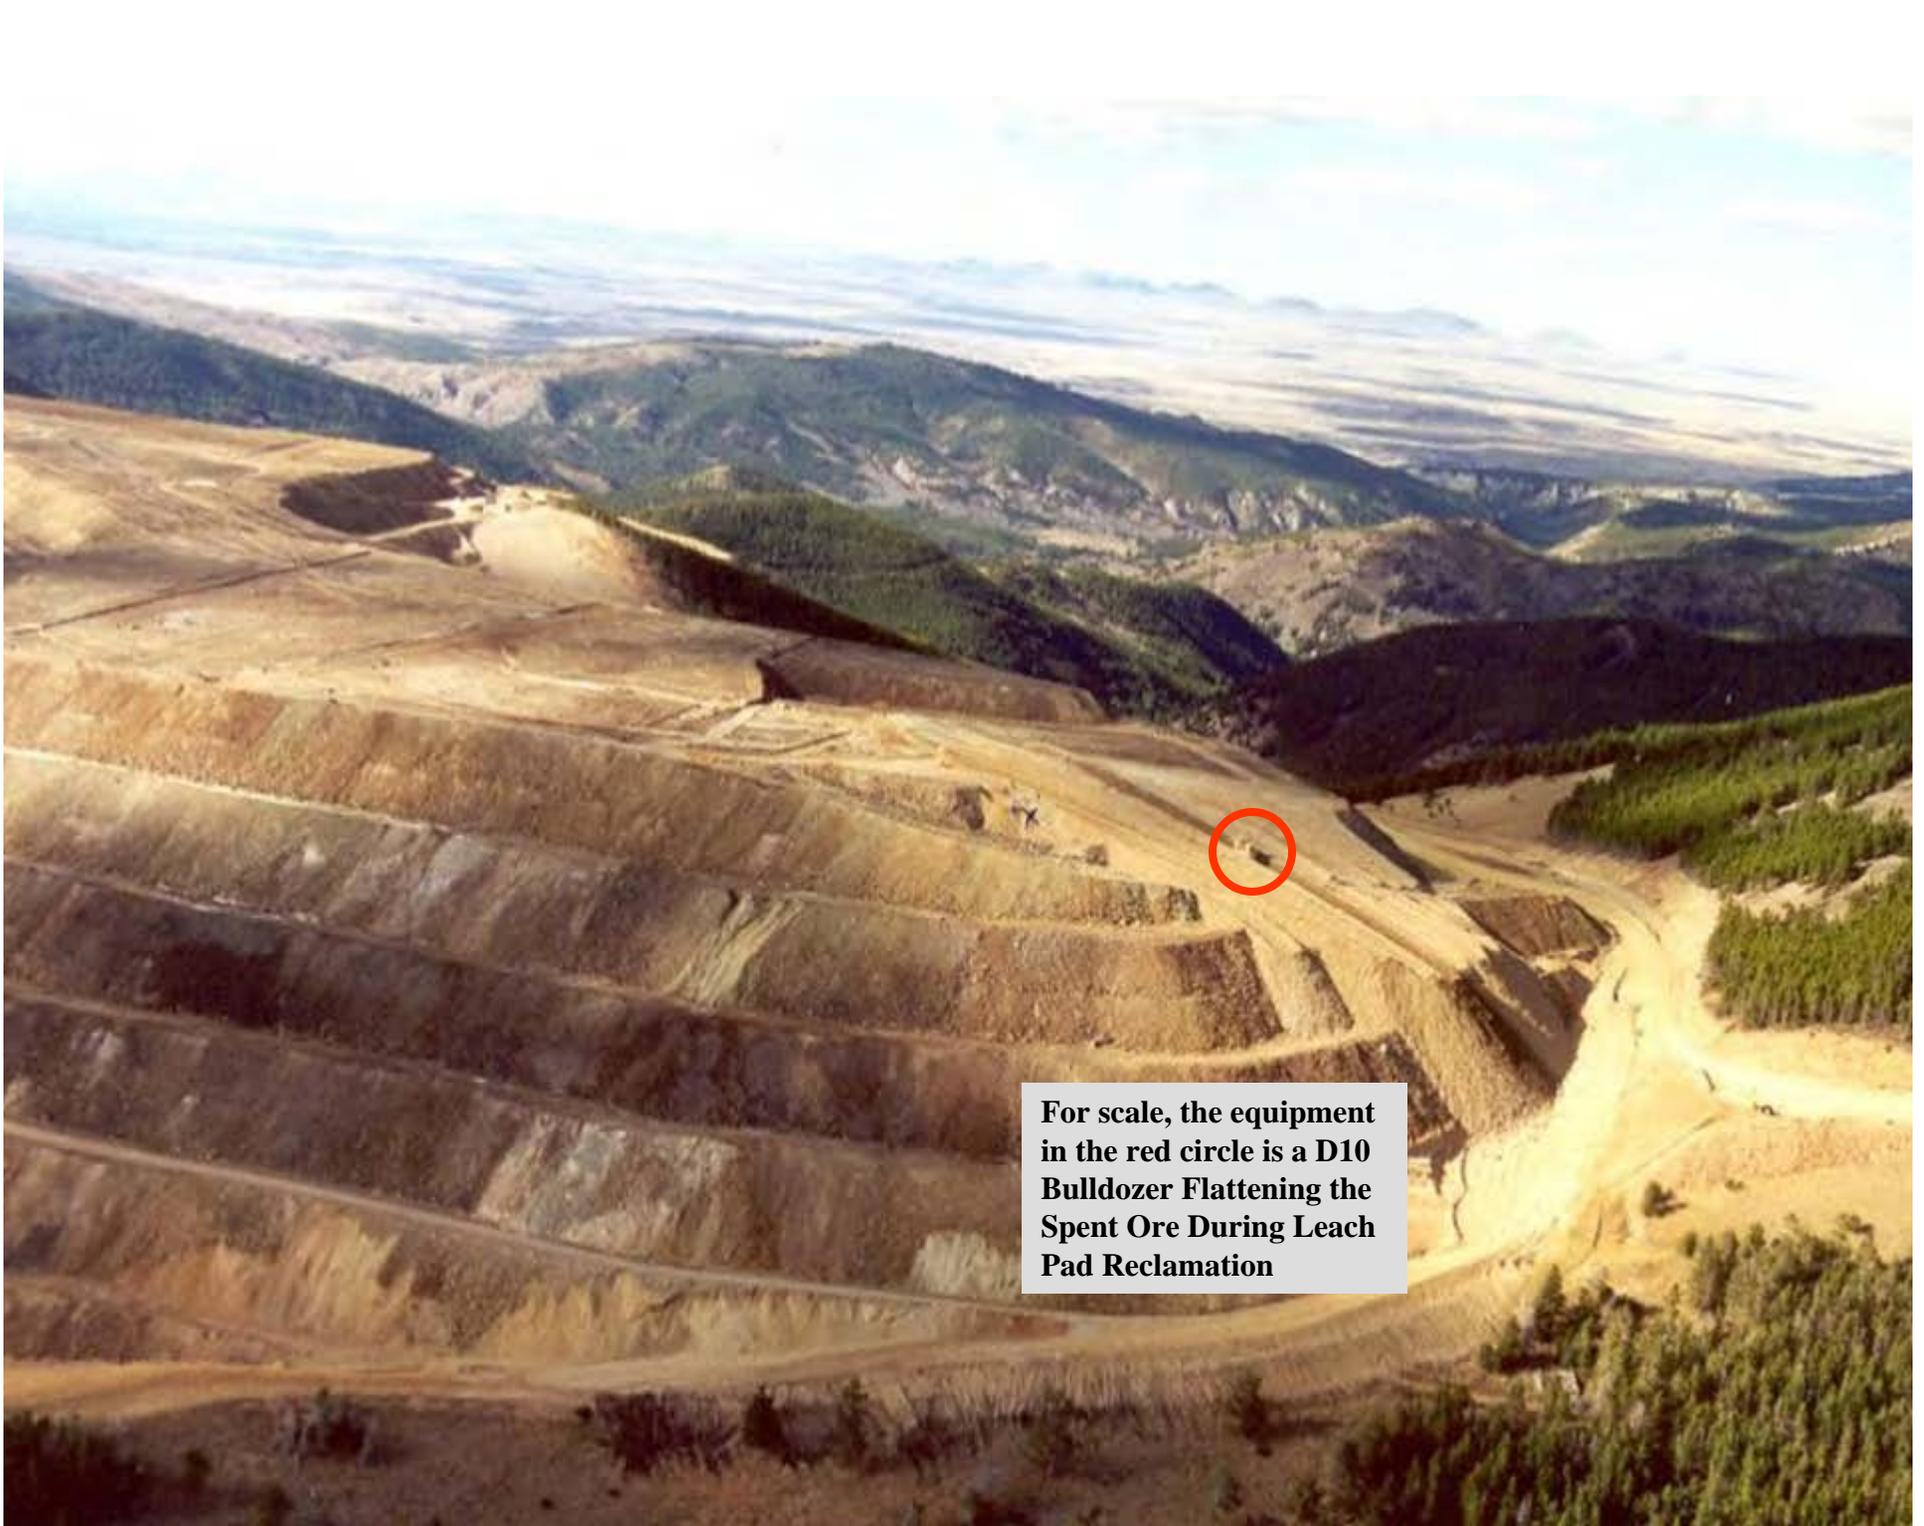
For scale, the equipment in the red circle is a D10 Bulldozer Flattening the Spent Ore During Leach Pad Reclamation

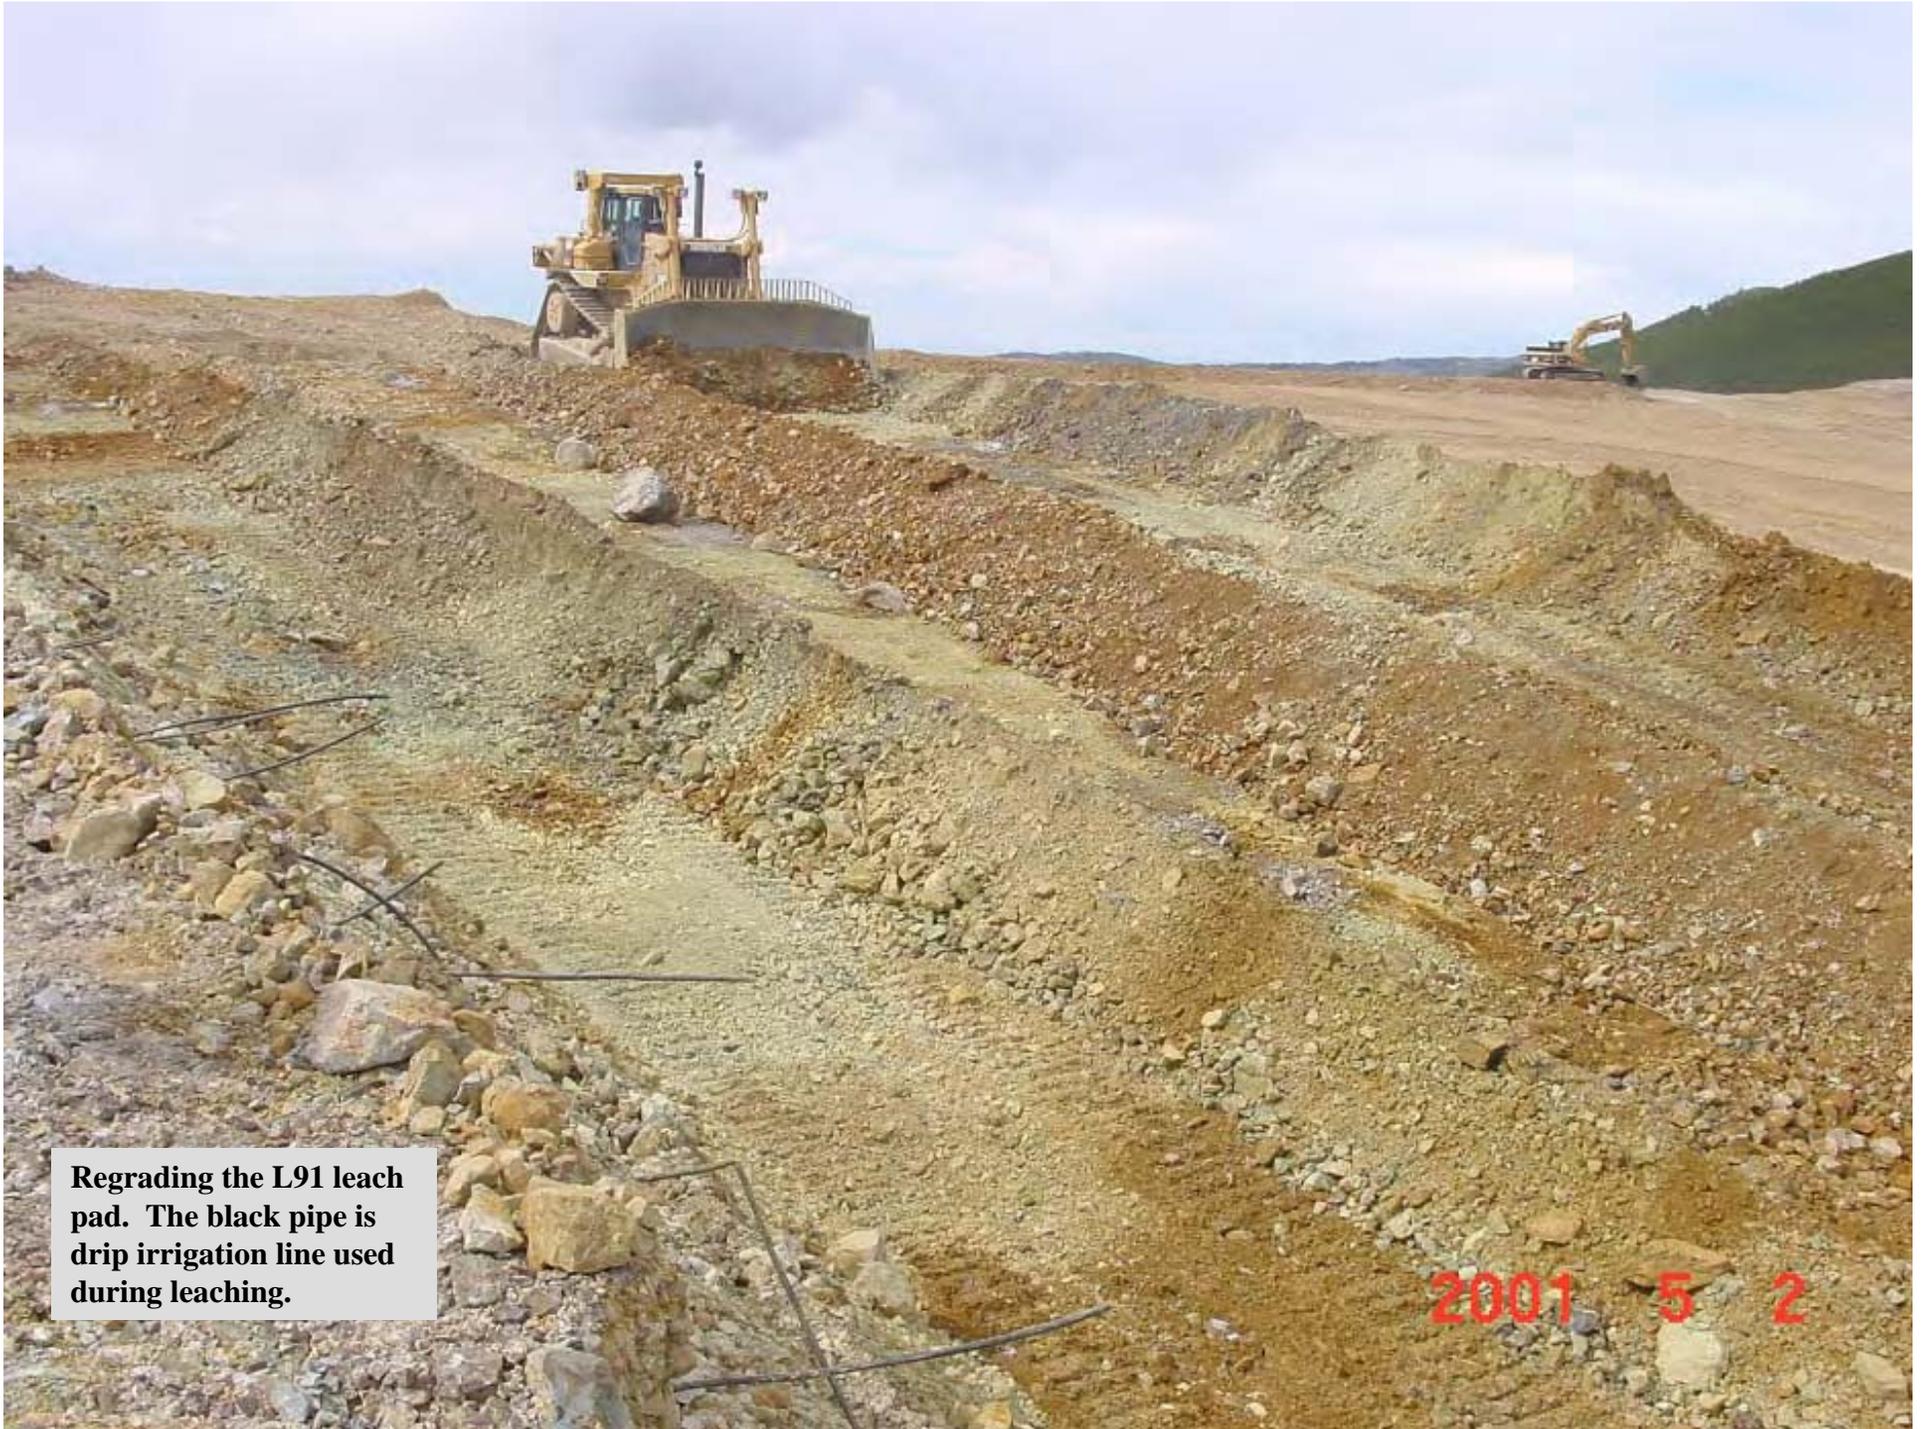
Regrading the L91 leach pad. The black pipe is drip irrigation line used during leaching.

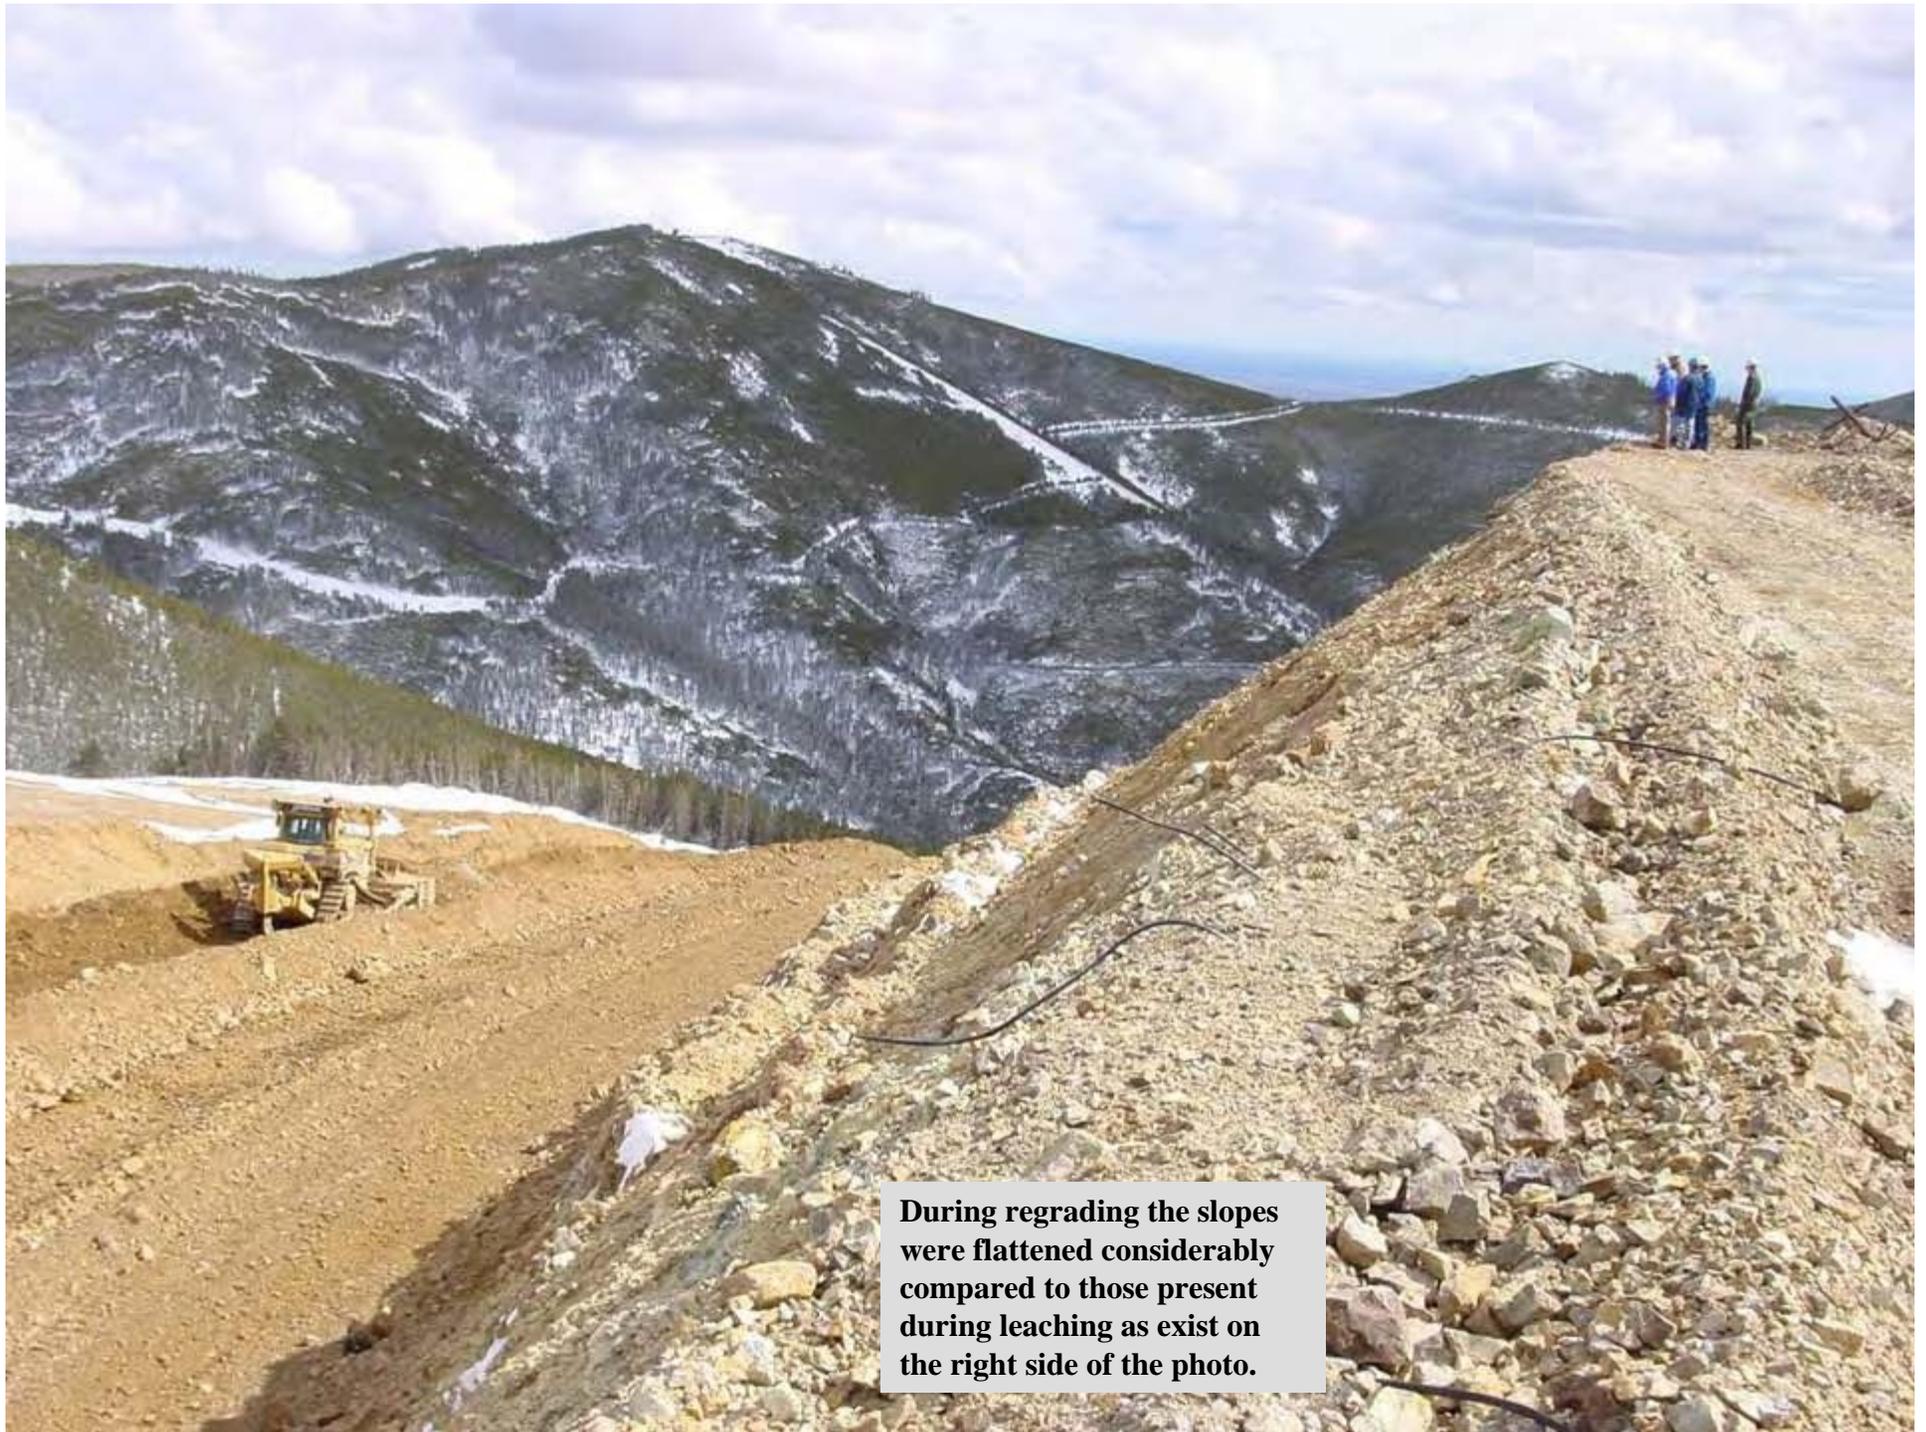
During regrading the slopes were flattened considerably compared to those present during leaching as exist on the right side of the photo.

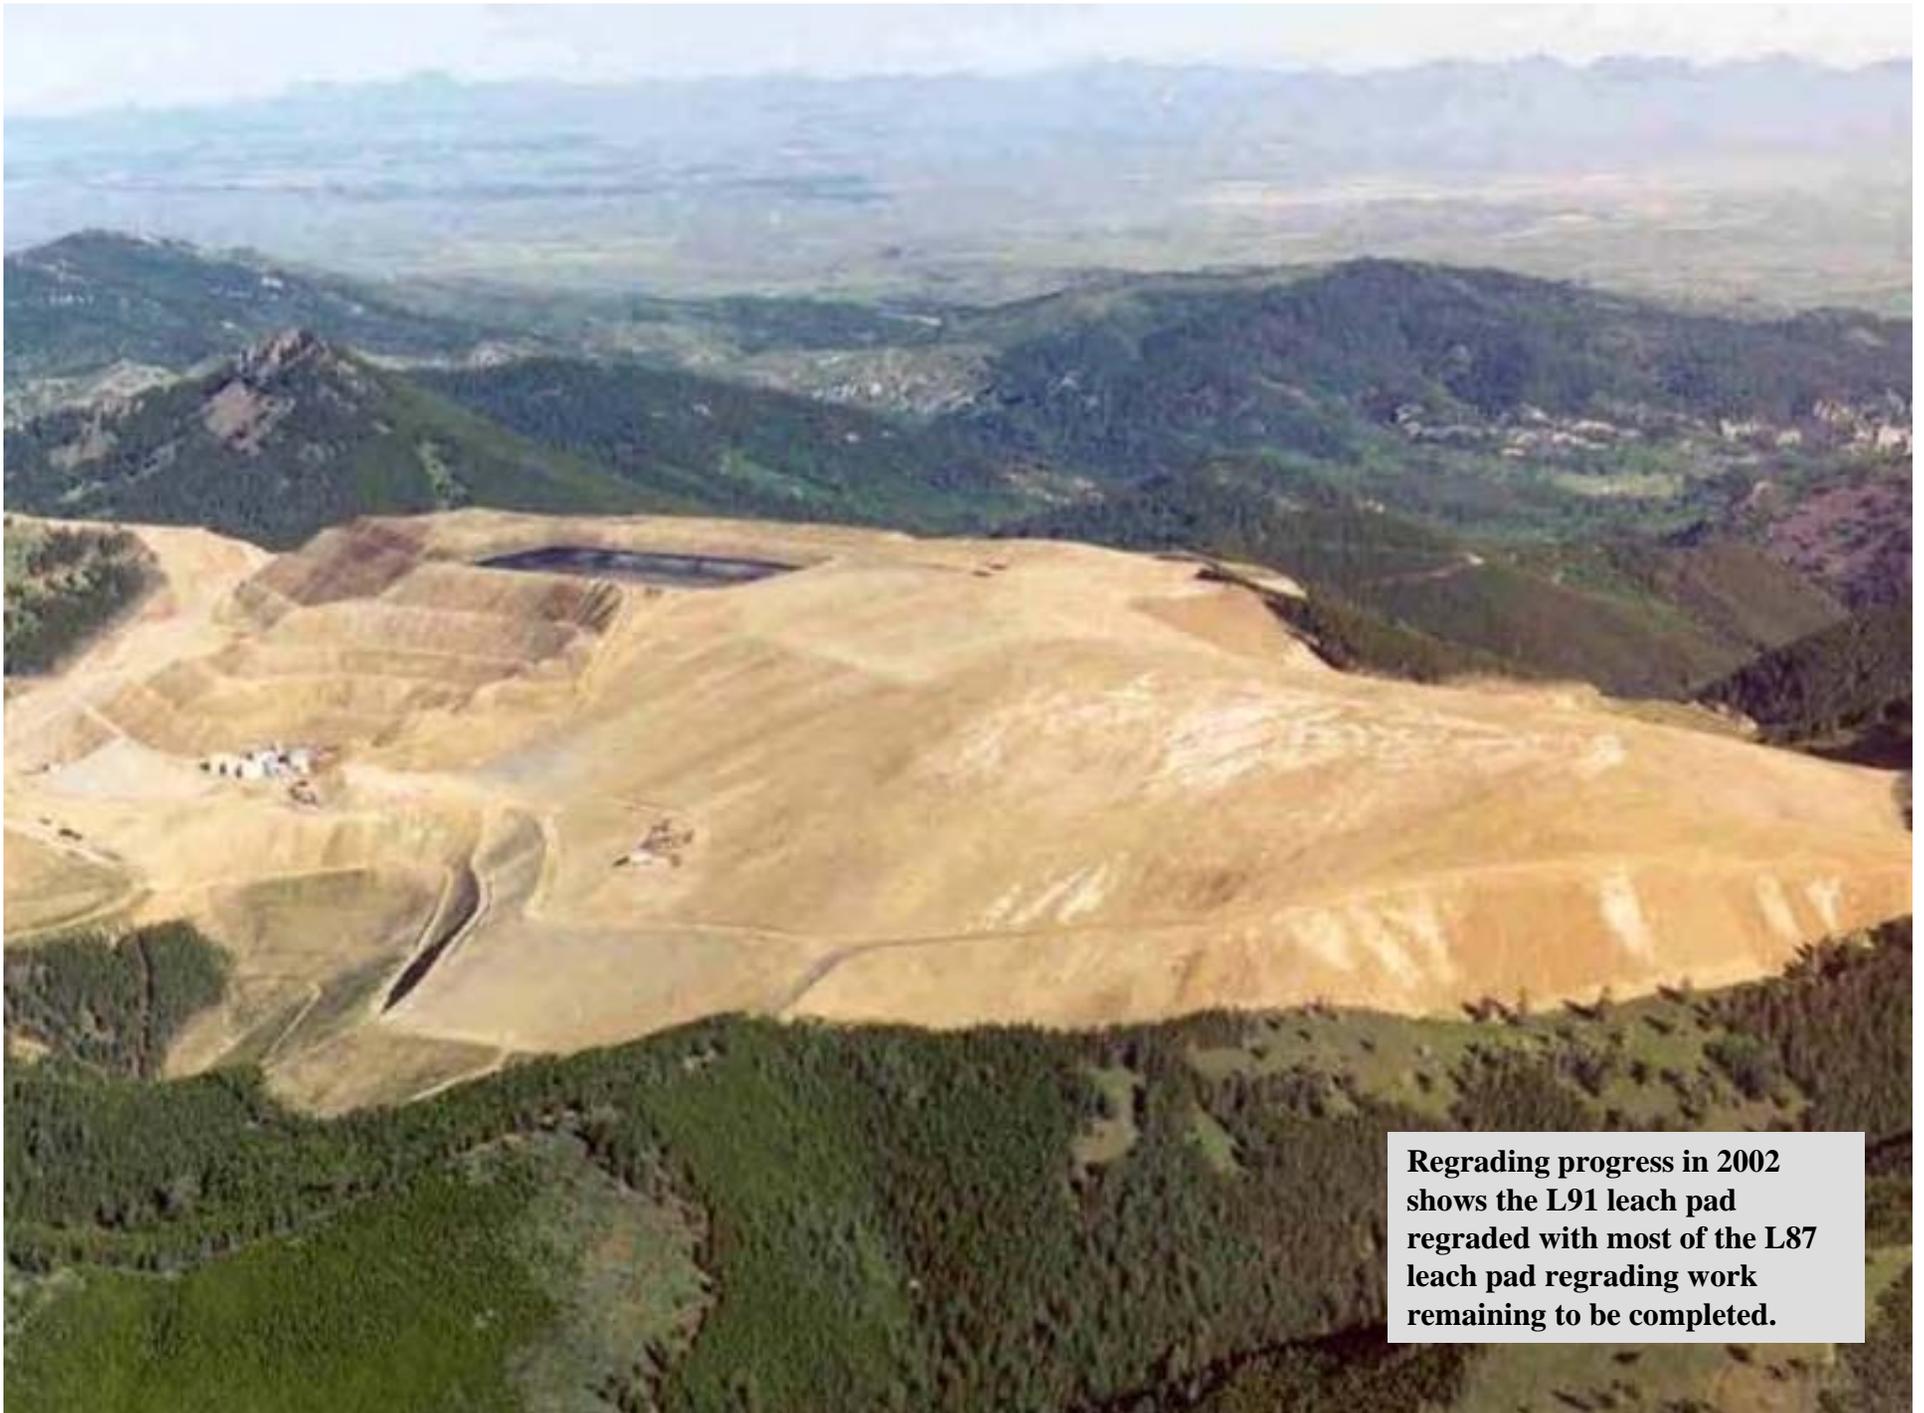
Regrading progress in 2002 shows the L91 leach pad regraded with most of the L87 leach pad regrading work remaining to be completed.

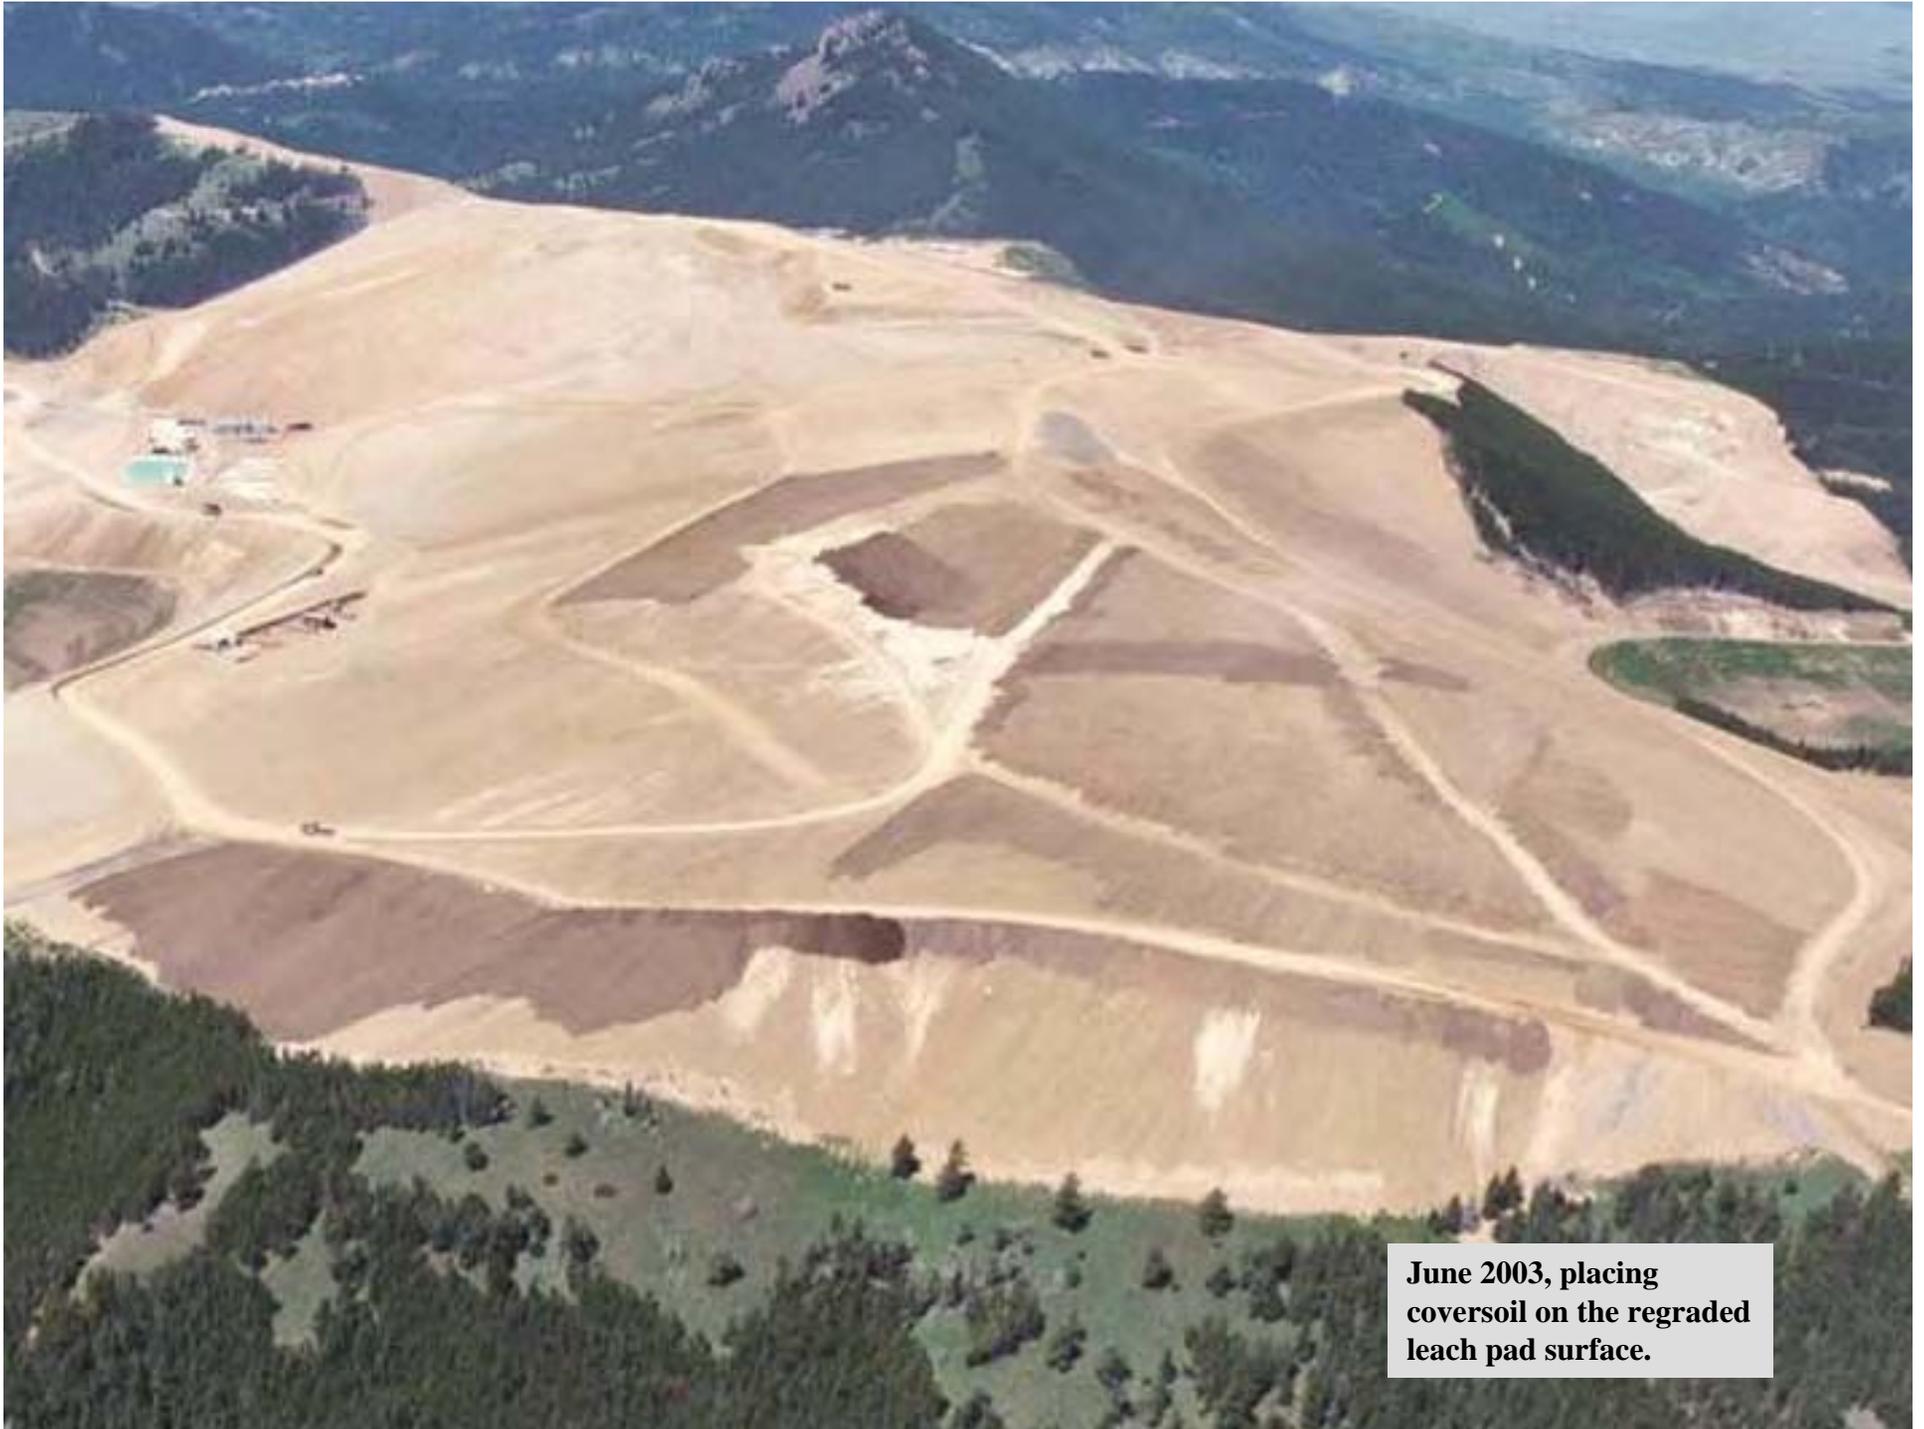
June 2003, placing coversoil on the regraded leach pad surface.
